**SAS Superstructure**

Location: 04-SF-80-13.2 / 13.9

Daily Diary Report by Bid Item

Diary #: 231 Const Calendar Day: 899 Date: 24-Feb-2012 Friday

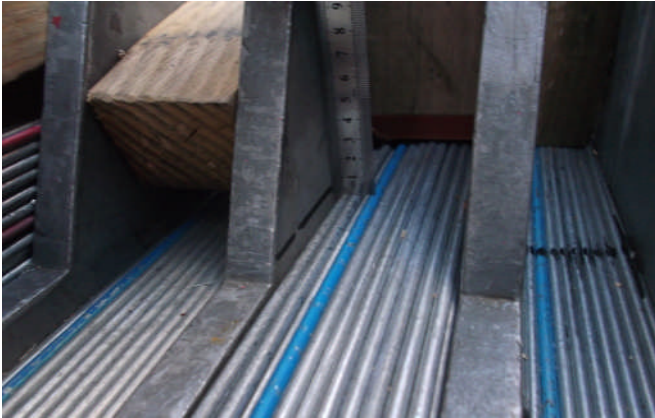
- From 09:20 until 09:40, I walked the North & South side-spans to check strand #59 for twist and damage. None was noticed.
- From 10:00 until 10:25, I was doing general inspection of installed strands #56 thru #58. I noticed no issues. Part of the inspection included checking the height of the installed strand on #58 in the North trough. I marked this trough with an inspection line to check to see how the strand height looks while they are using the new forming & installing methods recently adopted. The strand height varied from 58mm to 60mm (plan = 58mm) for the entire length of the saddle. See attached photo.

Instaled strand #58-North at Tower, height = about 58mm at about 5mm below the inspection line marked 63mm above strand below.
